MISCELLANEOUS PAPER M-77-12

## EVENT DICE THROW MOBILITY EXPERIMENTS

Mobility and Environmental Systems Laboratory  
U. S. Army Engineer Waterways Experiment Station  
P. O. Box 631, Vicksburg, Miss. 39180

September 1977

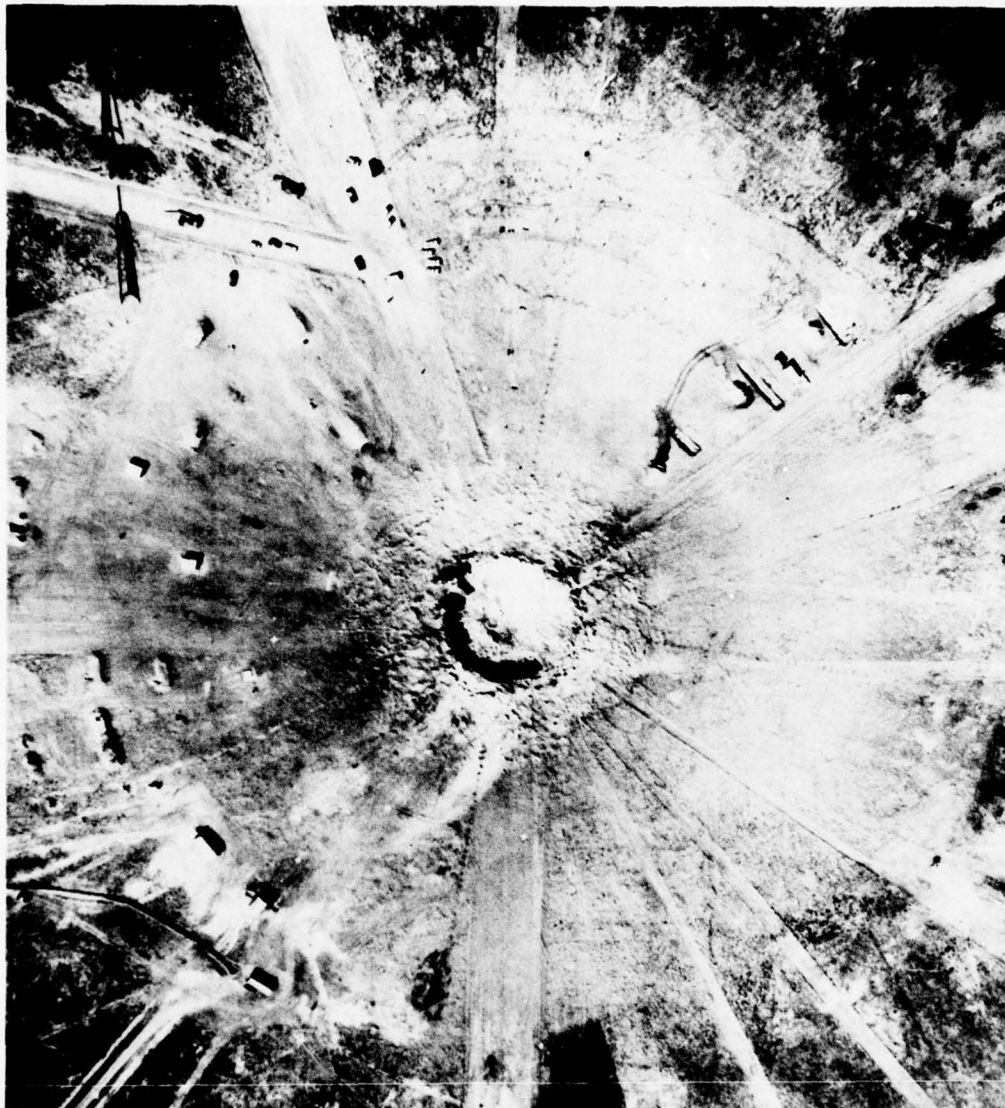
Figure 2.2. Aerial photograph of DICE THROW crater.

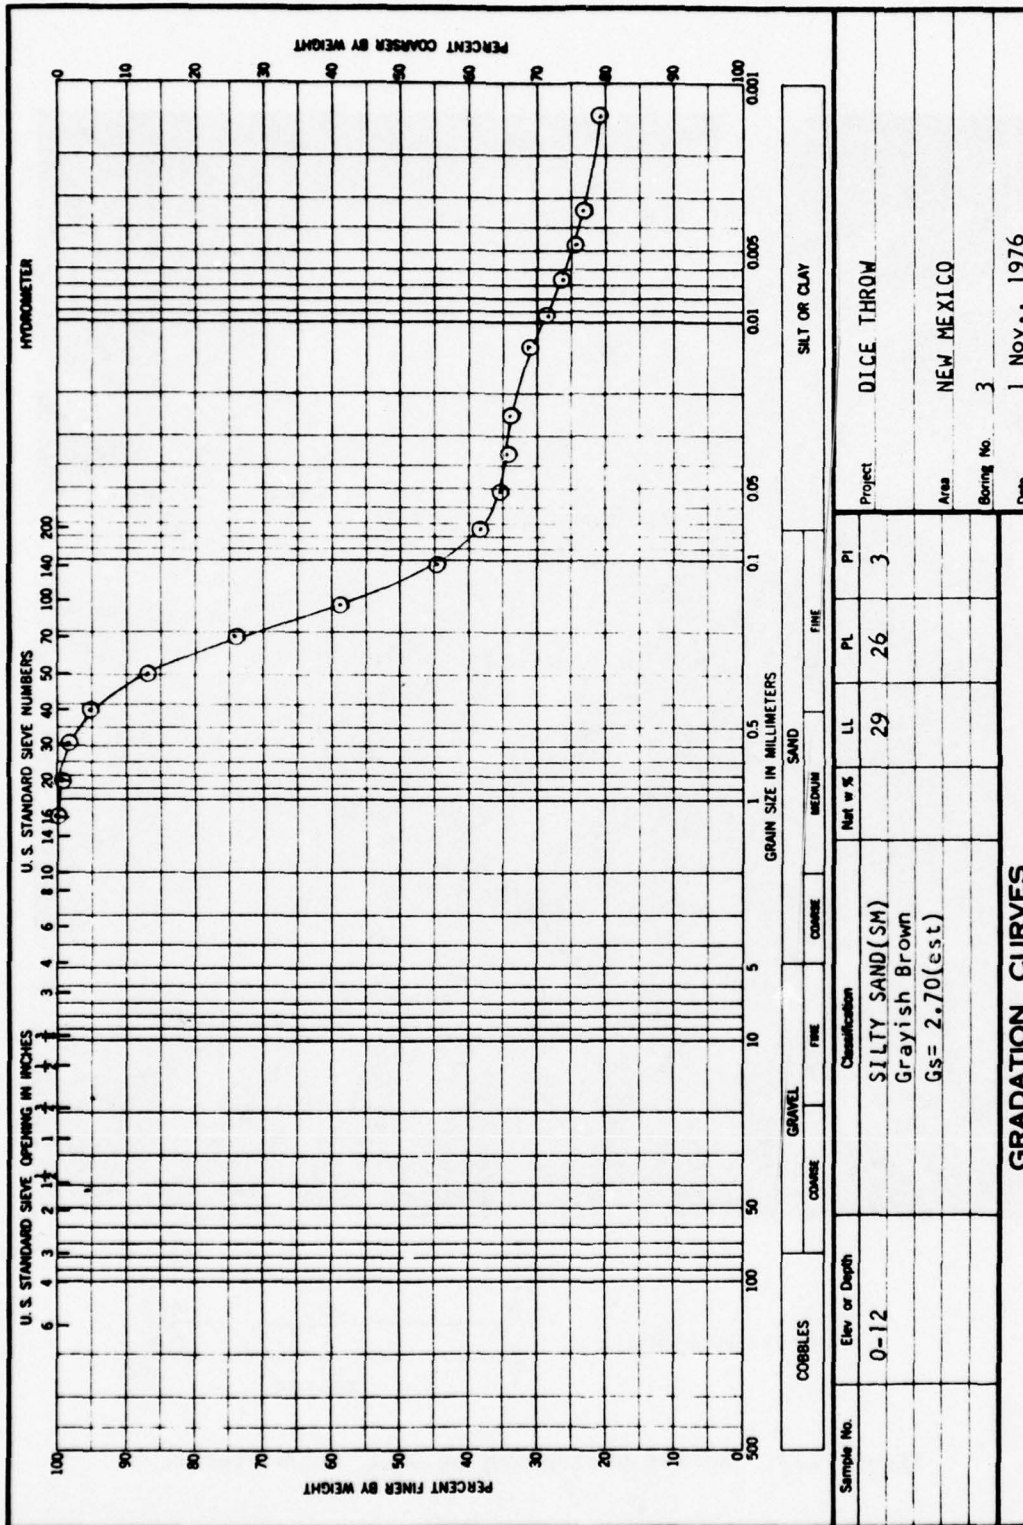
Figure 2.3. Soil classification data for DICE THROW crater.

At the time of the mobility tests, the surface of the area beyond the ejecta was fairly smooth, with a sparse grass cover. The surface in the ejecta area was composed predominantly of loose, sandy material (Figure 2.3) sprinkled with clods of the same material. These clods were small, scattered, and golf-ball size near the outer edge of the ejecta of the crater, increasing near the crest to baseball size.

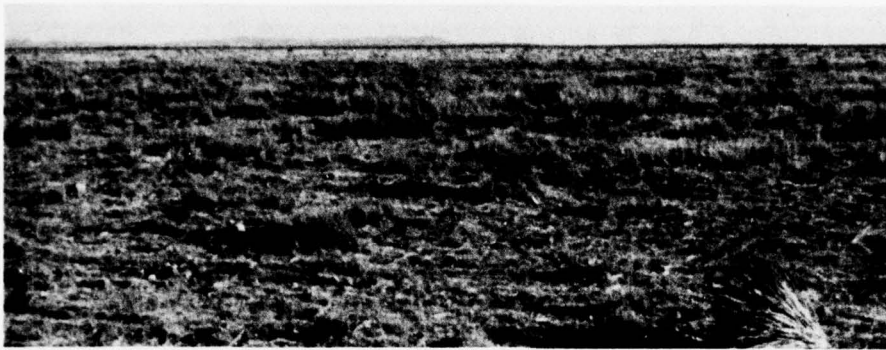
Figure 2.4. Overview of area beyond the ejecta field (Terrain Unit 1).

The steepest parts of the crater slopes were smooth; the more gentle portions near the bottoms of the slopes contained clods of the same size as on the outer edge. Figures 2.4-2.8 show the surface conditions from beyond the ejecta field to the floor of the crater.

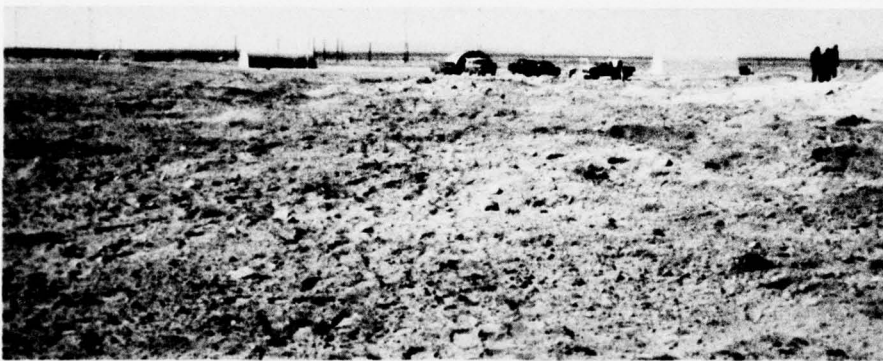
Figure 2.5. Overview of outer lip (Terrain Unit 2).

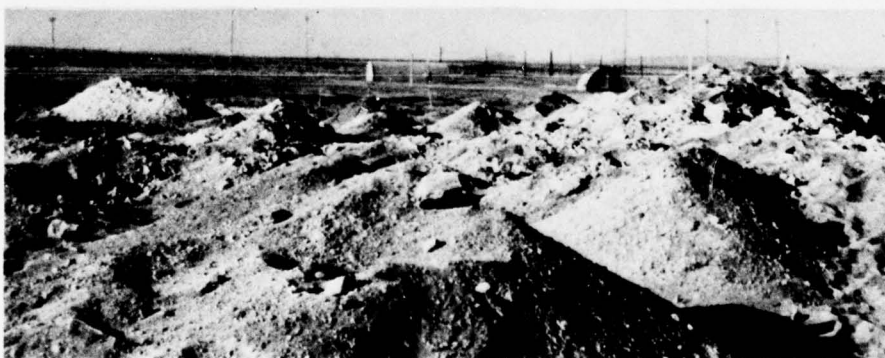
Figure 2.6. Overview of inner lip (Terrain Unit 3).

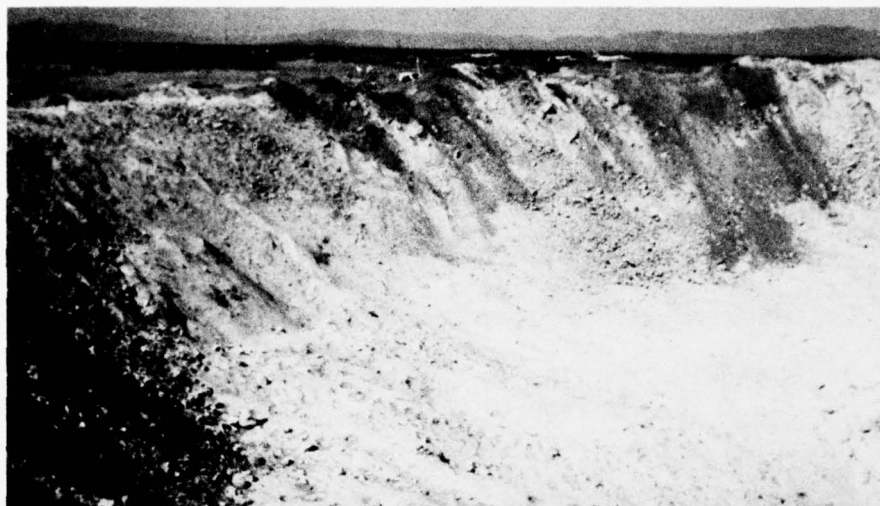
Figure 2.7. Overview of crater wall (Terrain Unit 4).

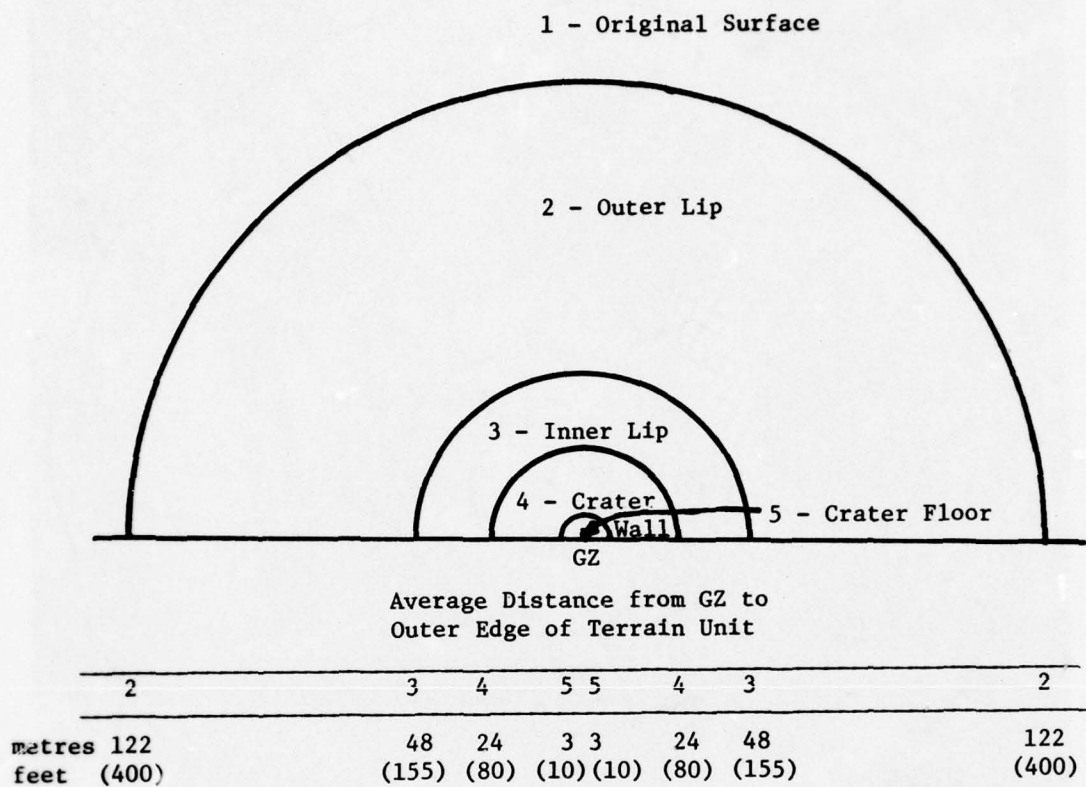
a. Plan View

b. Profile Sketch

Figure 2.15. Schematic of terrain units for DICE THROW crater.  
GZ = ground zero.

Terrain data were taken to describe the crater for mobility purposes and to relate vehicle performance to specific terrain attributes. Data for description purposes were taken along a line drawn through the center of the crater. A schematic of the terrain units of the crater is shown in plan view along with a profile sketch in Figure 2.15. Surface composition (type of material, strength, moisture content, and density) and surface geometry data were measured for each terrain unit. The same terrain data also were measured in each of the areas selected for vehicle tests. The test areas in Figure 2.16 are those areas in which terrain data were measured.

Using the dimensions given in Figure 2.15, the areas occupied by Terrain Units 2 through 5, inclusive, are shown in the following tabulation along with the speed degradation in percent.

In a combat situation, the major concern may be the width of the no-go area rather than the areal effectiveness, for example, how wide a pass could be blocked with a particular charge. Using the dimensions shown in Figure 2.15 the effective no-go width was approximately 48 metres (160 feet), which indicates that a similar charge in the same soil conditions would be effective in combat conditions for creating obstacles in this width range.

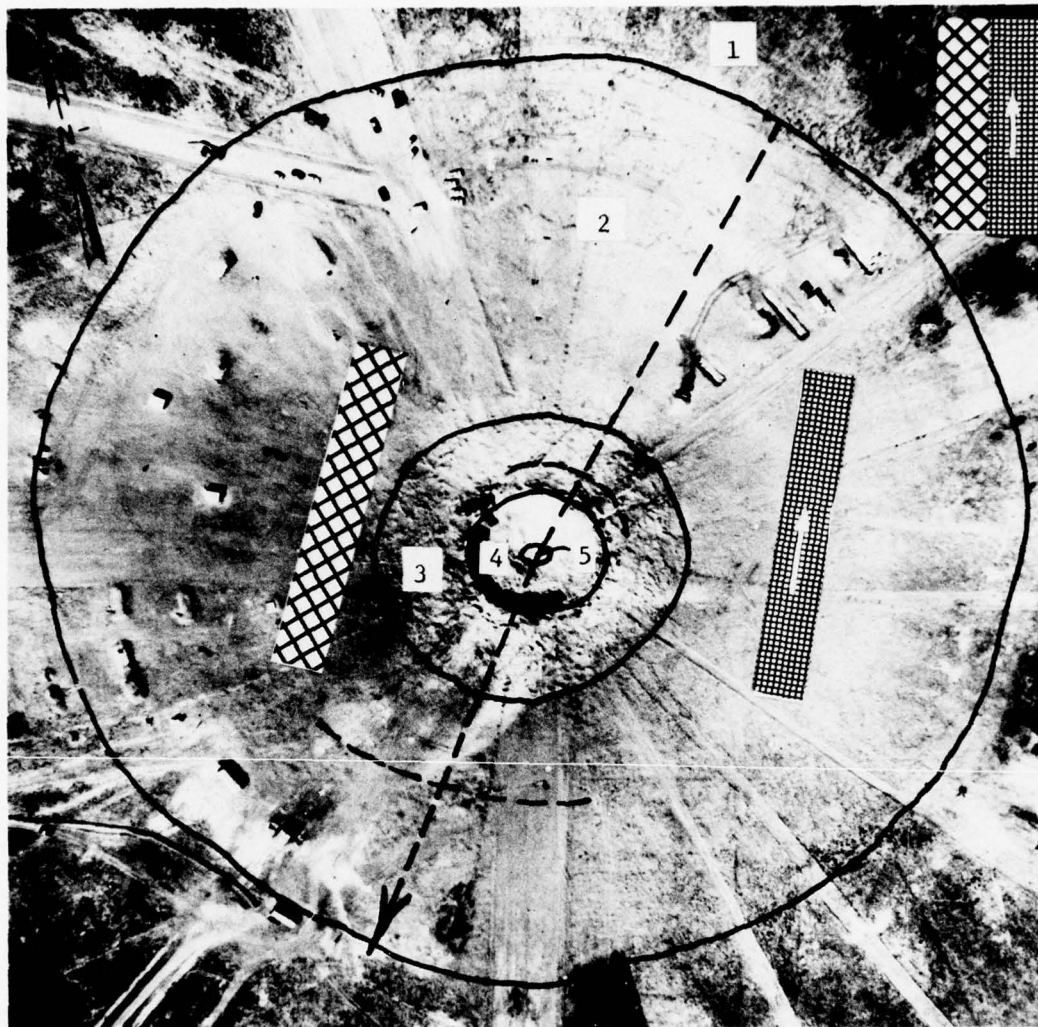
Terrain Unit		Straight dashed line indicates approximate locations of elevation profiles and go-no go vehicle tests. Arrow indicates direction of go-no go tests. Curved dashed line indicates locations of microprofiles.
No.	Description	
1	Original Surface	
2	Outer Lip	
3	Inner Lip	
4	Crater Wall	
5	Crater Floor

Figure 2.16. Aerial photograph of DICE THROW crater with terrain units and test locations identified

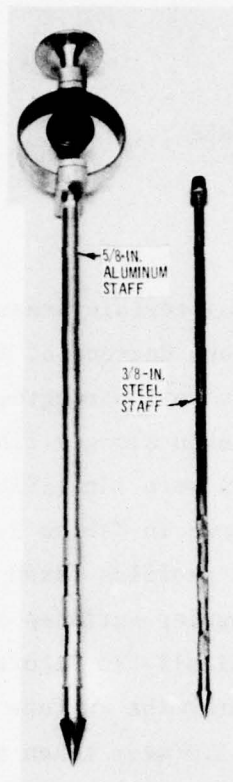
Figure 2.17 Cone penetrometer.

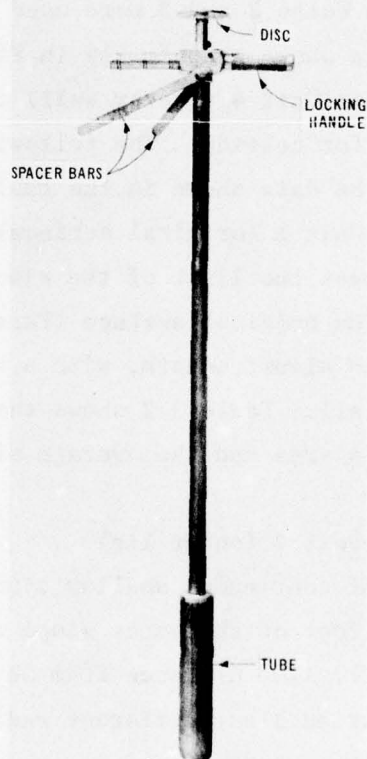
Figure 2.18 Trafficability sampler.

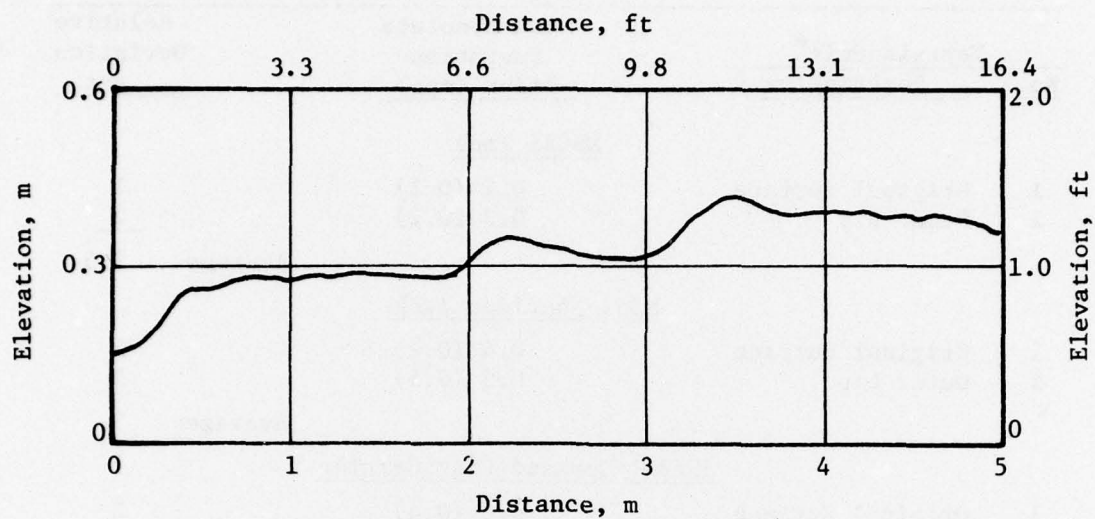
Figure 3.1. Microprofile of a typical section of Terrain Unit 2 (outer lip) roughly parallel to crater wall.

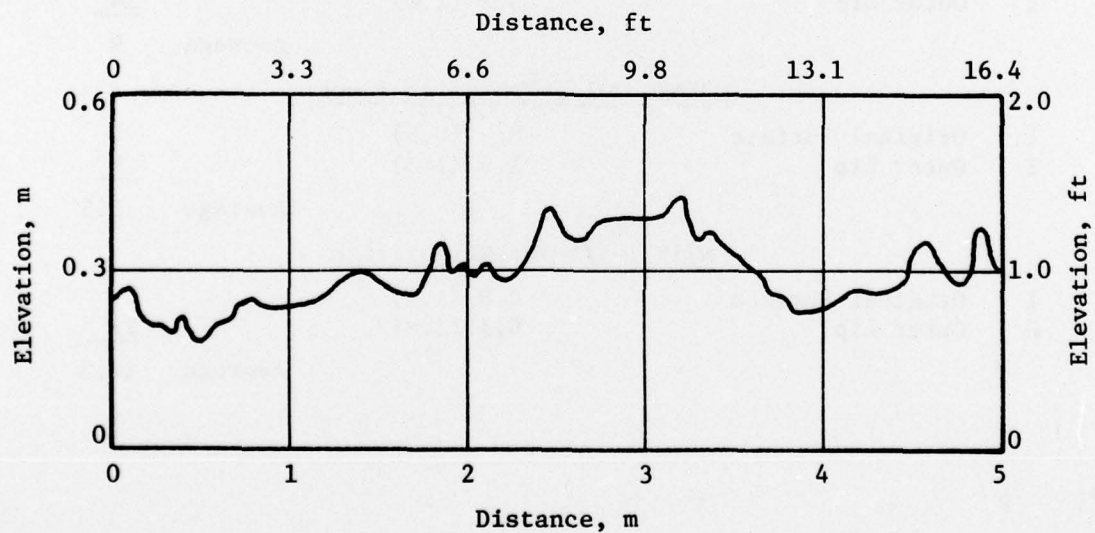
Figure 3.2. Microprofile of typical section of Terrain Unit 3 (inner lip) roughly parallel to crater wall.

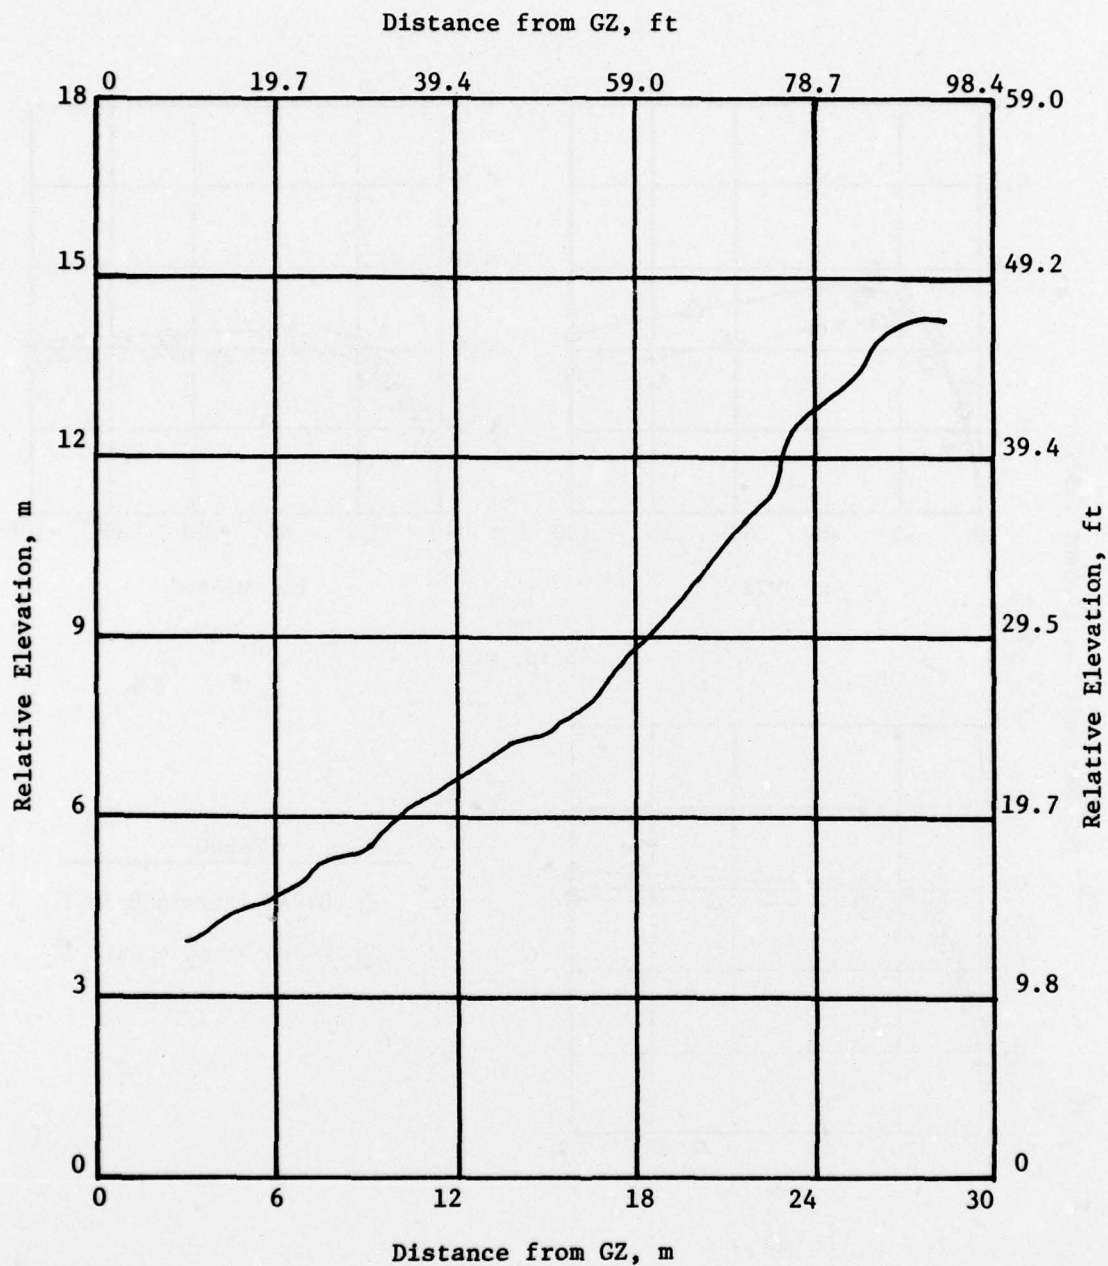
Figure 3.3. Elevation profile of Terrain Unit 4, crater wall of maximum slope.

The sloping sides of the craters extending from the lip crest to the toe of the slope at the edge of the crater floor were identified as the crater wall (Terrain Unit 4). The distances from GZ to the outer and inner boundaries of this area varied along different radii of the crater. The loose, dry material on the slopes was greater than 610 mm (24 in.) deep, and the average soil strength was similar to that in Terrain Unit 3. The overall slope of the crater walls varied in magnitude at the upper and lower ends and along different crater radii. The minimum and maximum slopes were 50 and 56 percent, respectively. An elevation profile of the crater wall of maximum slope of the crater is given in Figure 3.3.

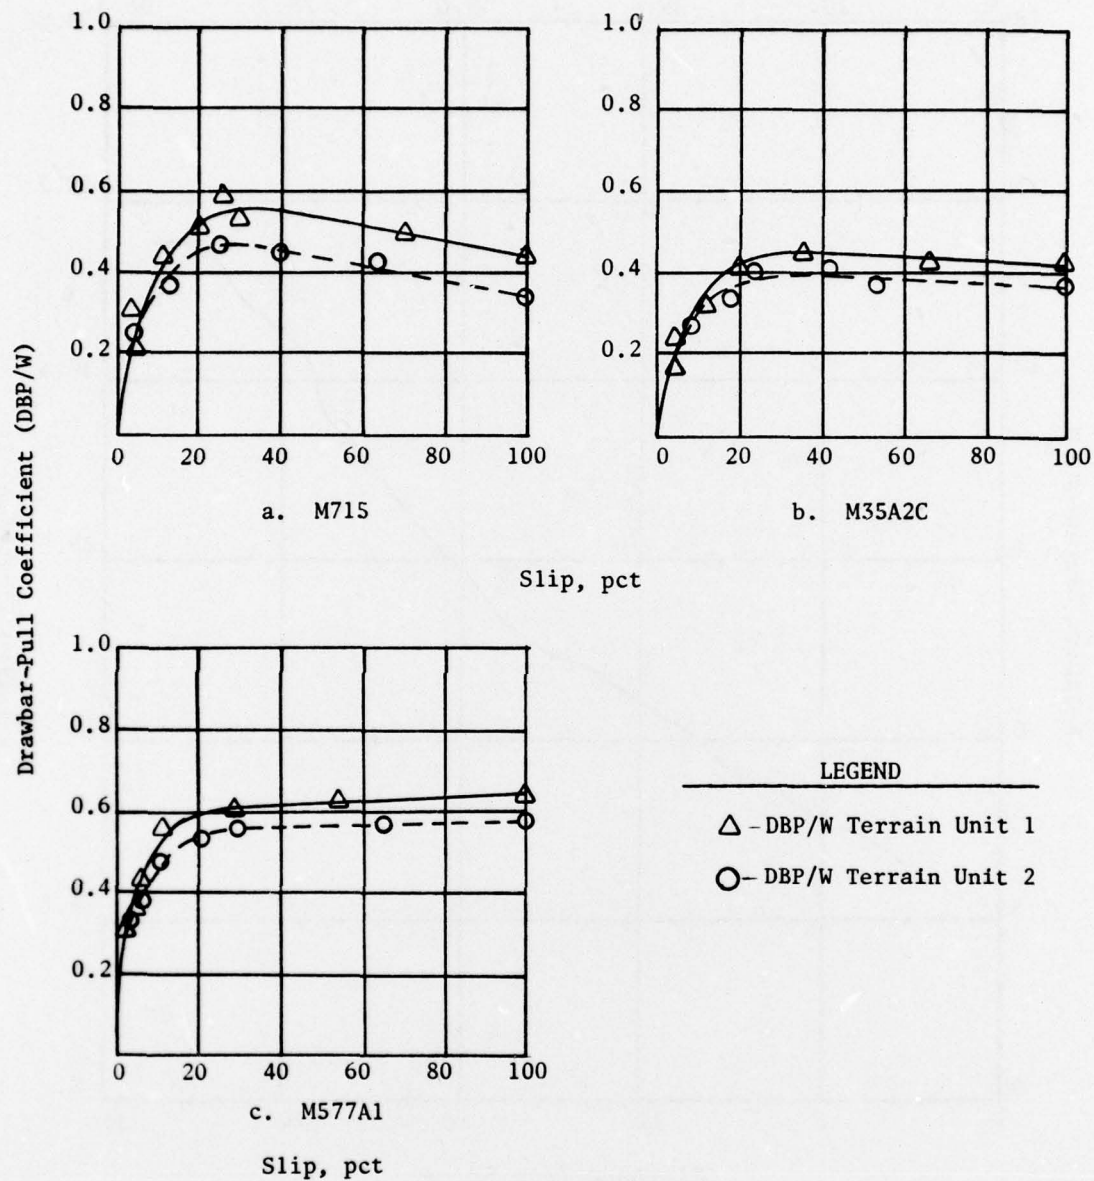
Figure 3.4. Drawbar-pull coefficient (DBP/W) versus slip.

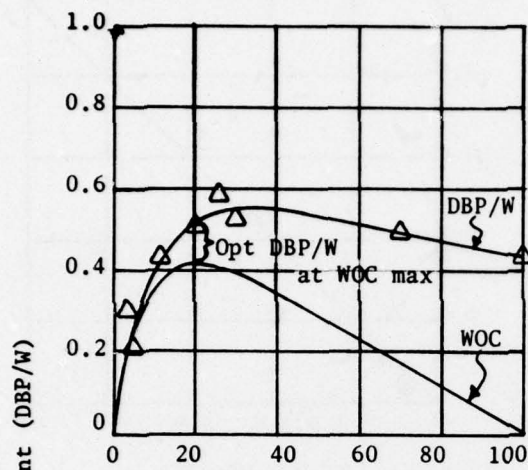
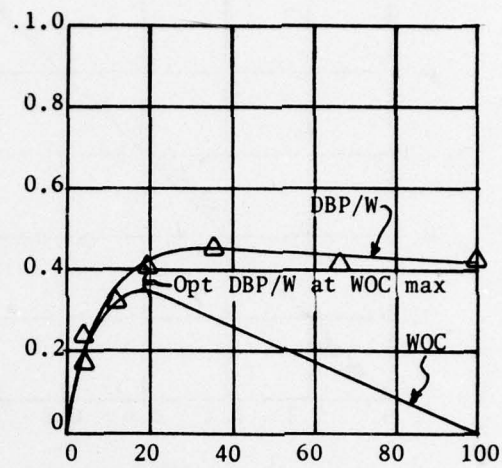
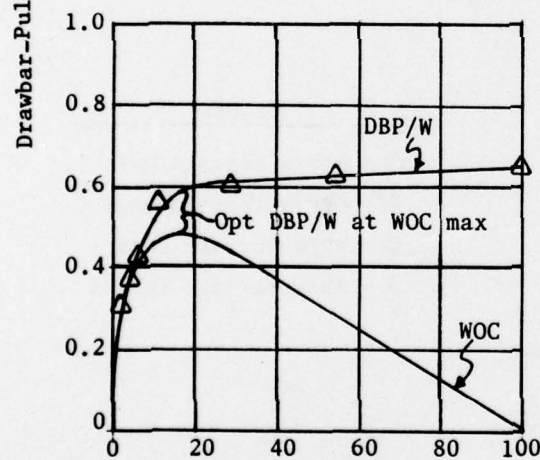
a. M715

b. M35A2C

c. M577A1

NOTE: Triangles indicate measured data.

Figure 3.5. Determination of optimum DBP coefficient (DBP/W) for three of the test vehicles in Terrain Unit 1.

An example of the determination of optimum DBP/W at maximum WOC for each test vehicle in Terrain Unit 1 of the crater is shown in Figure 3.5. Figure 3.5 shows that the optimum slip was 20 percent for the M715 and 18 percent for the M35A2C and the M577A1; the optimum DBP coefficients for the three vehicles in Terrain Unit 1 of the crater were 0.52, 0.43, and 0.59, respectively. Past studies at the U. S. Army Engineer Waterways Experiment Station (WES) have shown that optimum DBP generally occurs at or near 20 percent slip, as was found in the tests in this program.

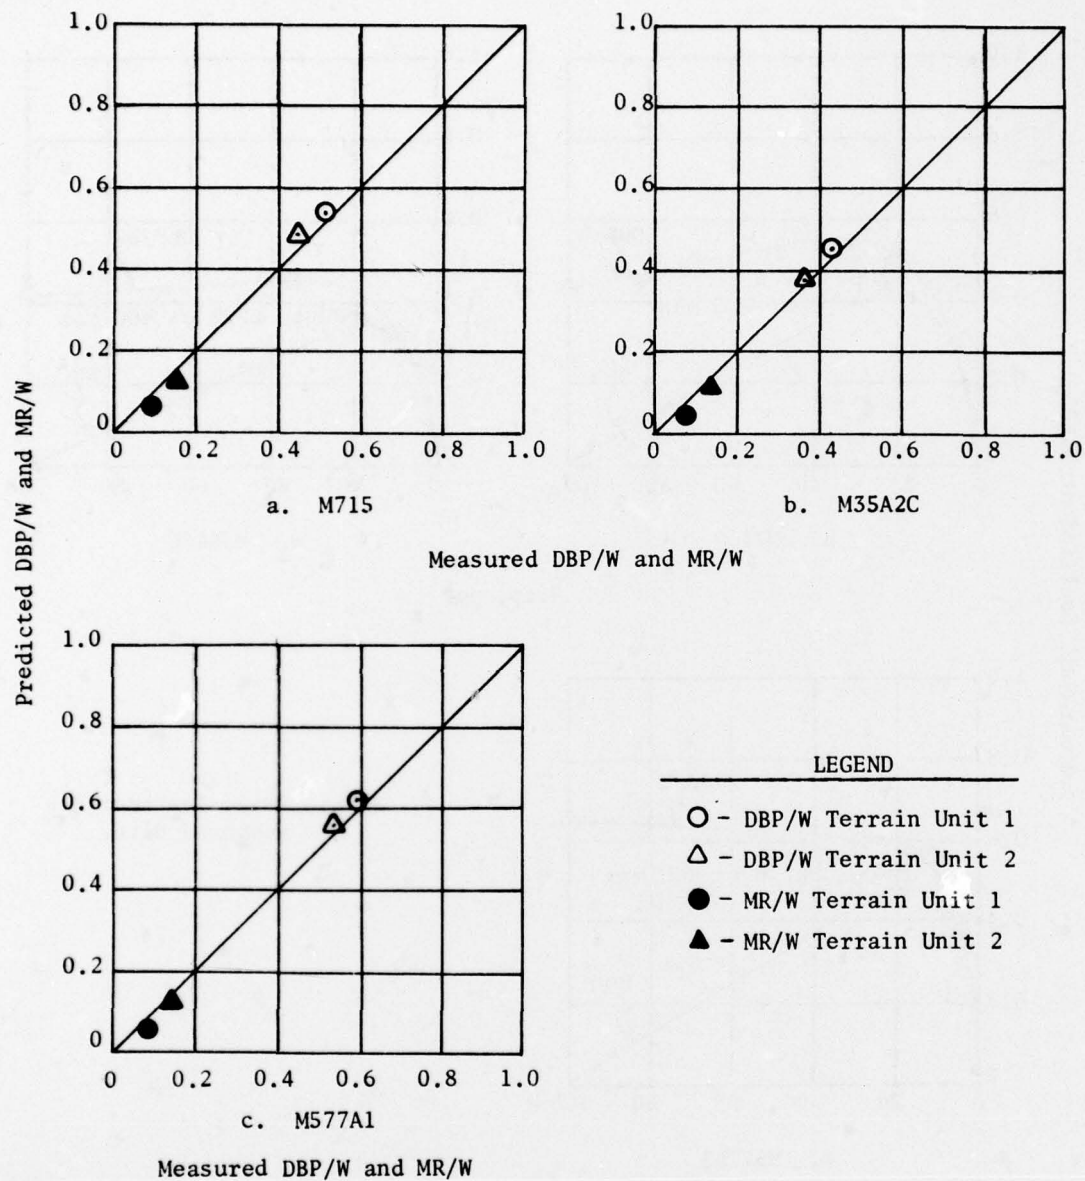
Figure 3.6. Comparison of measured and predicted DBP/W and MR/W for three of the test vehicles.

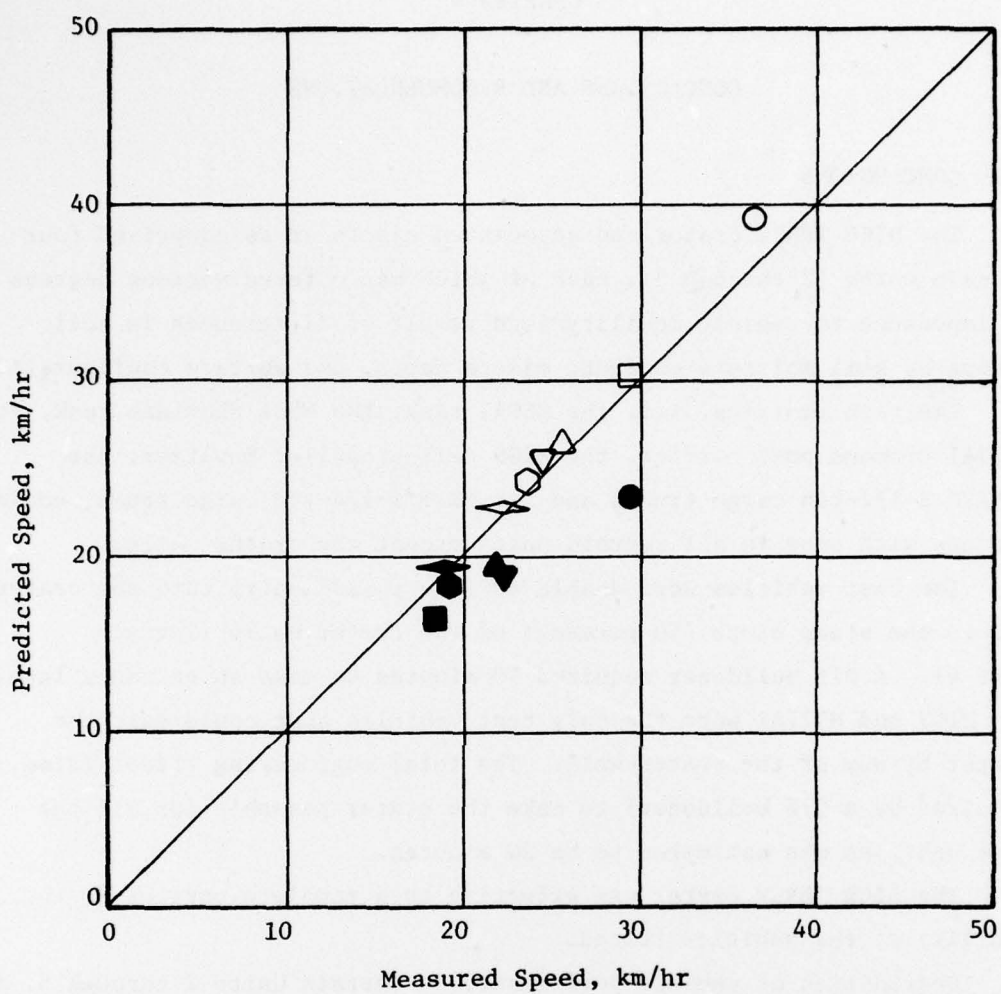
LEGEND		
Symbol	Vehicle	Terrain Unit
○	M715	1
●	M715	2
△	M35A2C	1
▲	M35A2C	2
◊	M551	1
◆	M551	2

LEGEND		
Symbol	Vehicle	Terrain Unit
□	M577A1	1
■	M577A1	2
▽	M109	1
▼	M109	2
◊	M60A1	1
◆	M60A1	2
